# Dust Collector Fire and Explosion Highlights Need for Combustible Dust Considerations In System Designs

*A massive fire and explosion in the dust collection system of a New Hampshire wood pellet manufacturer demonstrates the need for adequate system design to prevent combustible dust explosions in general industry.*

**May 16 2012 – Baghouse.com Editorial** | On October 20 2011, a combustible dust fire began in the wood pellet cooler, most likely caused by a spark or ember from the pellet hammer mill. The fire then spread through the ductwork throughout the plant, eventually reaching the dust collector causing it to explode. When the collector exploded, the explosion vented through the baghouse's explosion vents into adjacent storage silos setting them ablaze further spread the fire throughout the plant. More than 100 firefighters and emergency personnel from at least 14 towns worked for over 15 hours to put out the blaze.

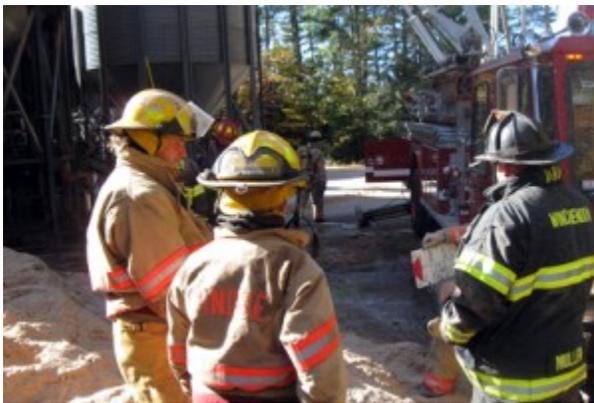
Fire fighters work to put out a massive blaze caused by a destructive combustible dust fire and explosion at the New England Wood Pellet Company’s Jaffrey, NH facility.
